MINE No. 60 - POND 5

BETHLEHEM MINES CORPORATION
ELLSWORTH-BUTLER DIVISION

PHASE I INSPECTION REPORT
NATIONAL DAM INSPECTION PROGRAM

MAY 1981

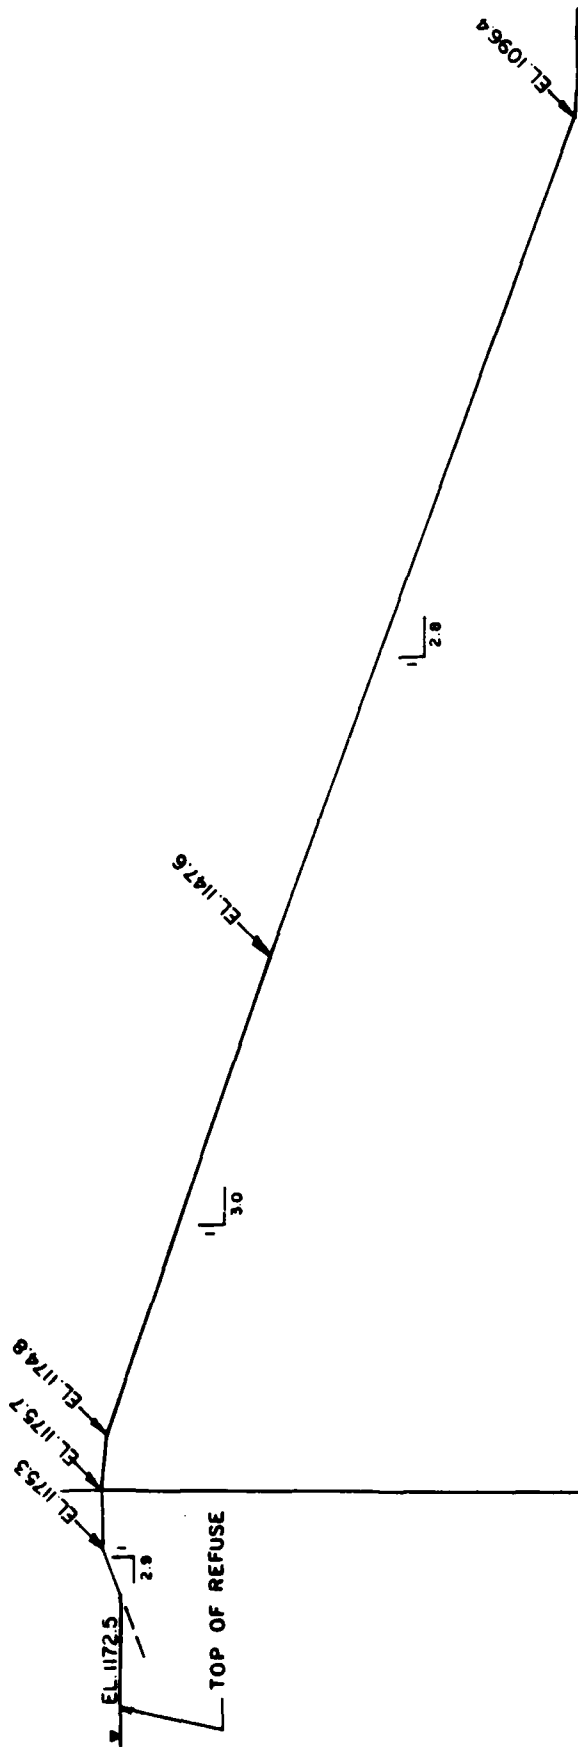
SECTION A-A
SCALE 1" = 30'

(1) Embankment: The field inspection disclosed no evidence of a high ground water level in the embankment. There was no pronounced "line of seepage"; and no significant buldges, surface sloughs, or cracking were observed. Two seepage zones were observed in the vicinity of the toe of the embankment. The zones contained soft and swampy conditions and a small amount of seepage was flowing from each zone. Field measurements indicated a relatively flat downstream slope varying from 3.0H:1V near the crest, to 2.8H:1V near the toe.
